Results obtained during tests performed on clamps, conical coupling muffers and driving heads

PART A. Report on results of the tests performed on clamps

Identification of the tested sample: GEN-58-I for grounding rod 5/8"

PART B. Report on results of the tests performed on conical coupling muffs

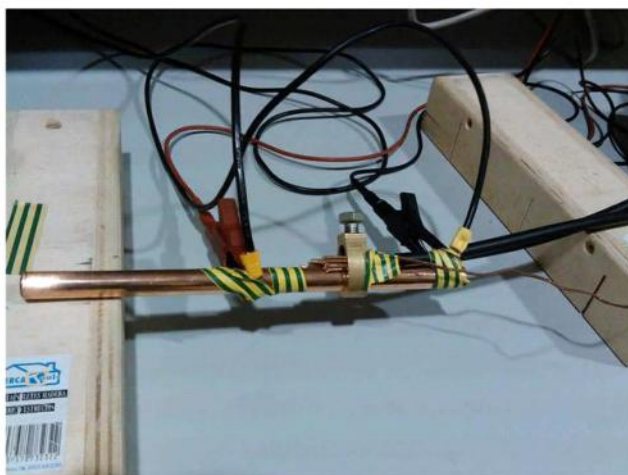
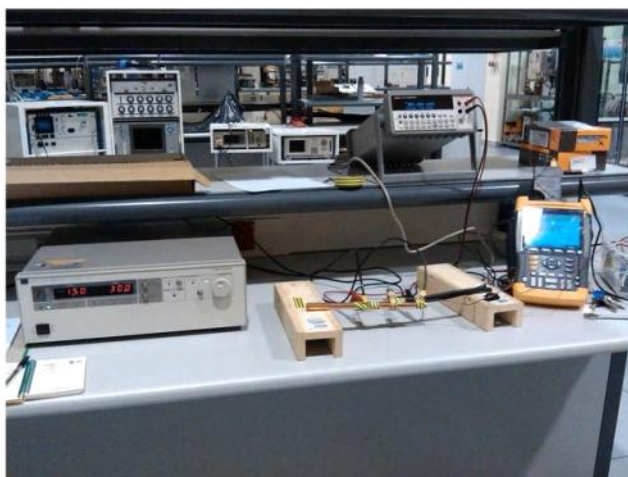
According to 7.2 from KEMA-standard K83C, the resistance of the connector was measured between points on the rod and the earth conductor with are 50 mm at either side of the connector, and the value was recorded.

Figure 1 and 2 show the assembly.

Experiments at two different intensities were carried out. The following table shows the results and the calculated resistance at 20°C taking into account the effect of the temperature.

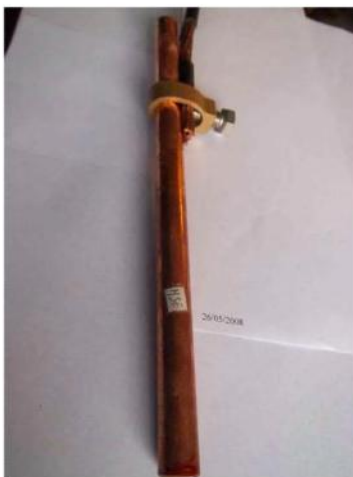
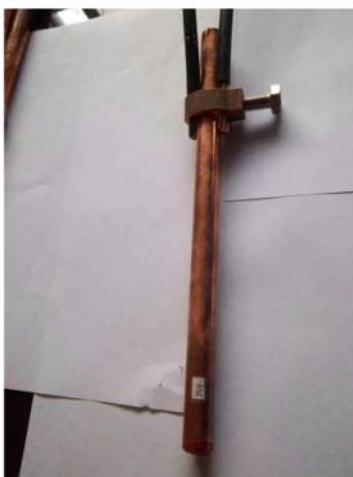
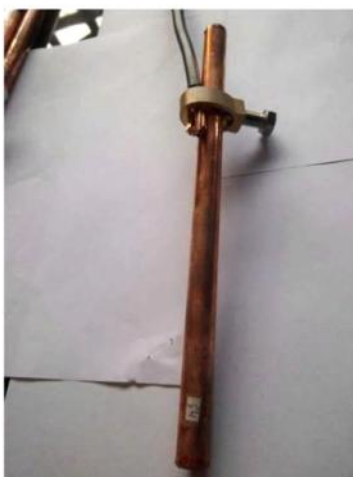
Figure 3. Sample N°1 t=0

Figure 4. Sample N°2 t=0

Figure 5. Sample N°3 t=0

RESULT: COMPLIES (see photographs at the beginning and after 504 hours)

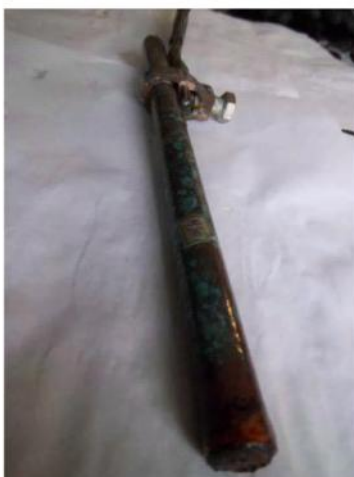
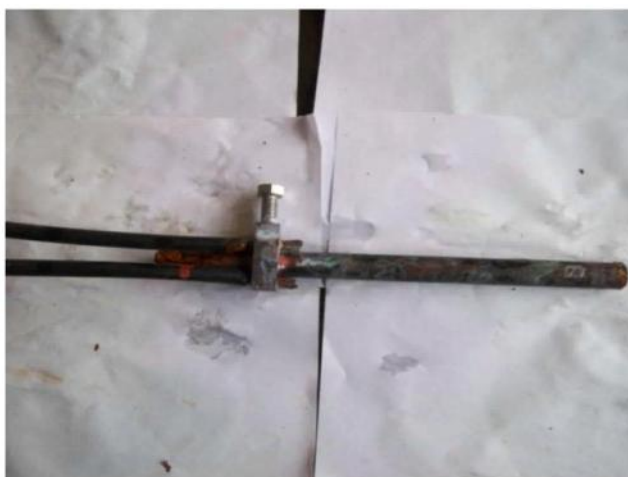
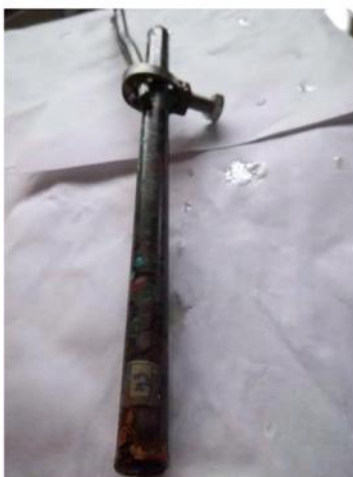
Figure 6. Sample N°1 after 504 h

Figure 7. Sample N°2 after 504 h

Figure 8. Sample N°3 after 504 h

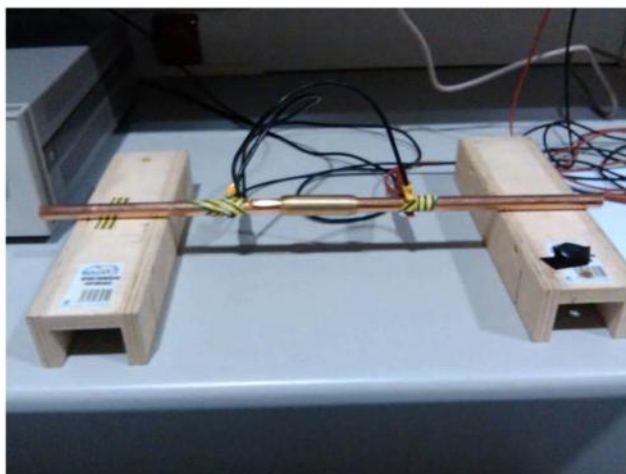
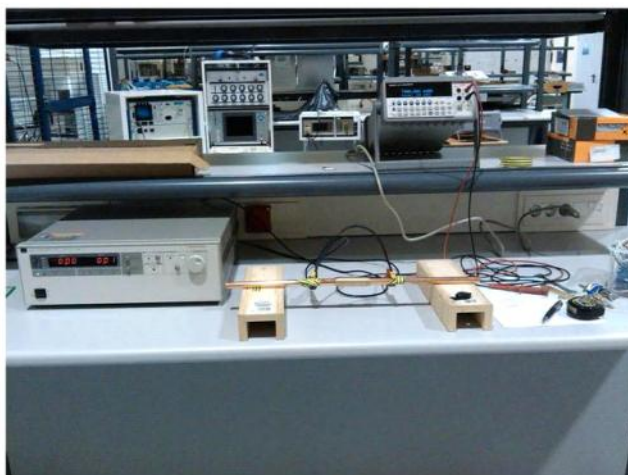
According to 5.5 from KEMA-standard K83C, the resistance of the joint was measured between points 50 mm at either side of coupler and the values were recorded.

Figure 11 and 12 show the assembly.

The following table shows the results and the calculated resistance at 20°C.

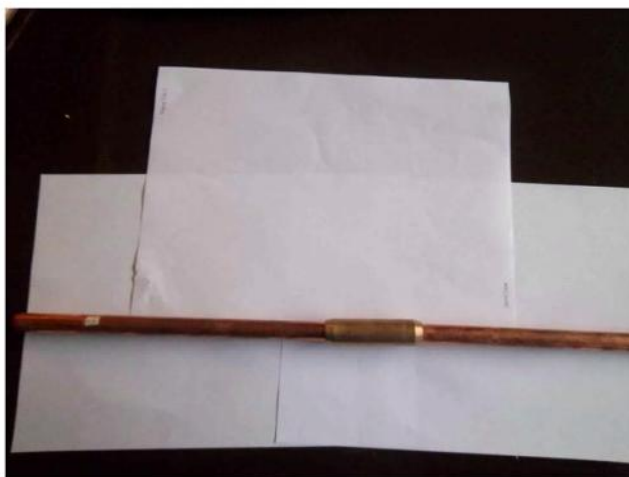
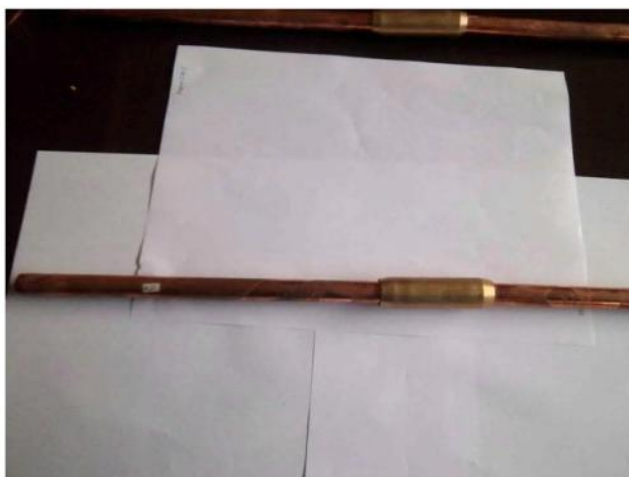
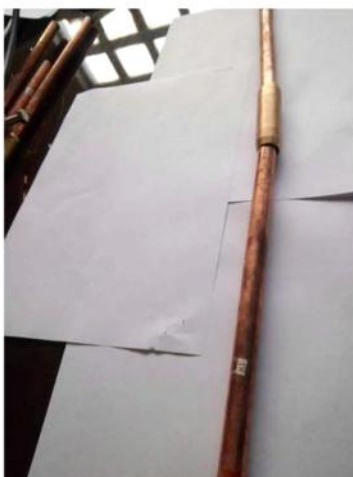
Figure 13. Sample 1 $t=0$

Figure 14. Sample 2 $t=0$

Figure 15. Sample 3 t=0

RESULT: COMPLIES (see photographs at the beginning and after 504 hours)

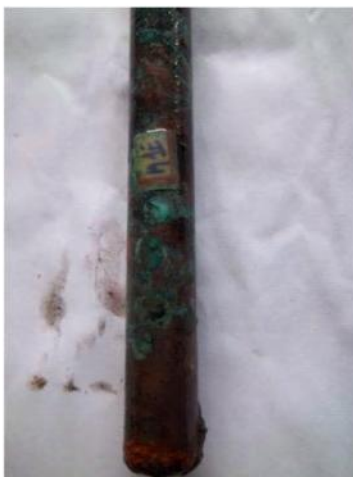
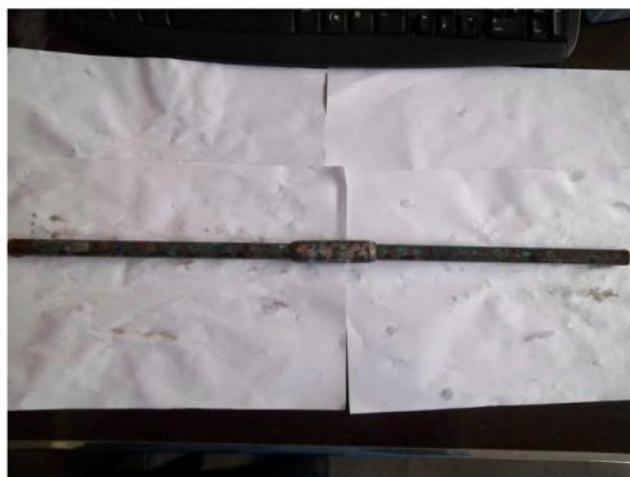
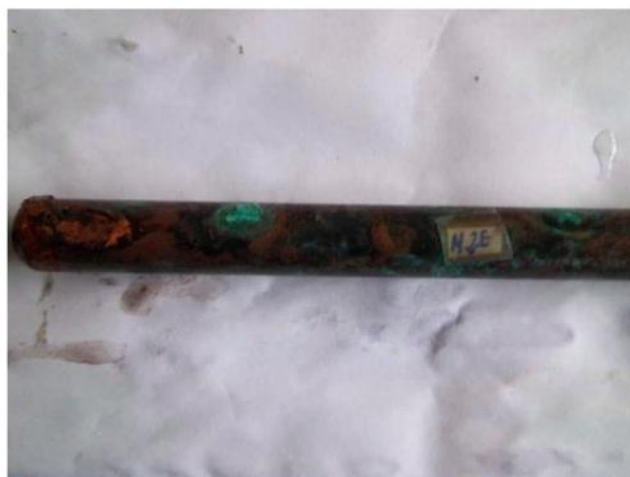
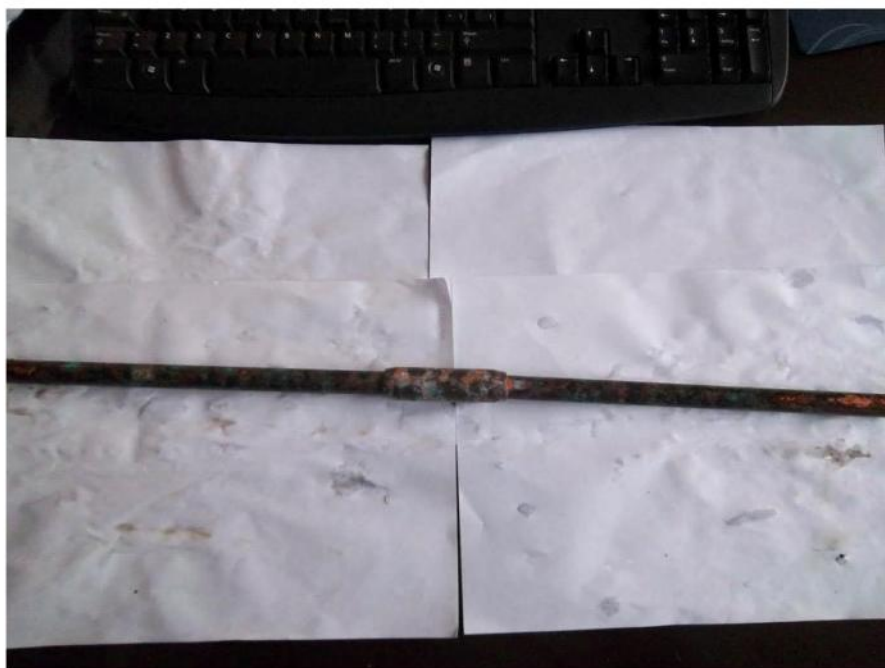
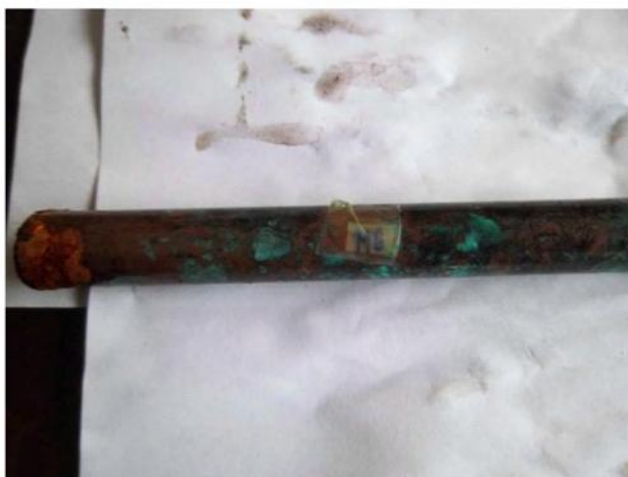
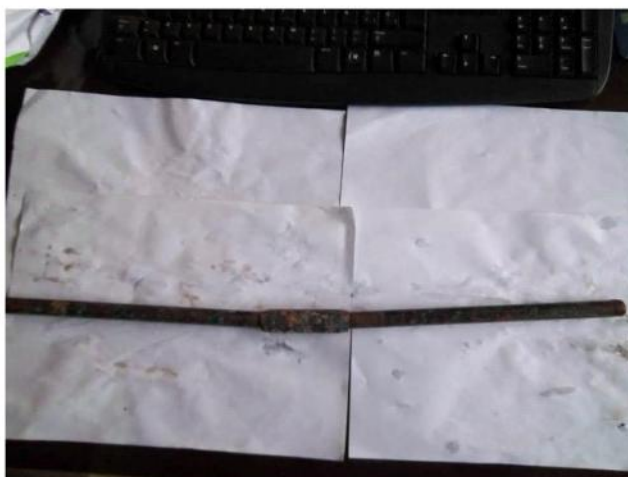
Figure 16. Sample 1 after 504 h

Figure 17. Sample 1 after 504 h

Figure 18. Sample 2 after 504 h

Figure 19. Sample 2 after 504 h

Figure 20. Sample 3 after 504 h

Figure 21. Sample 3 after 504 h

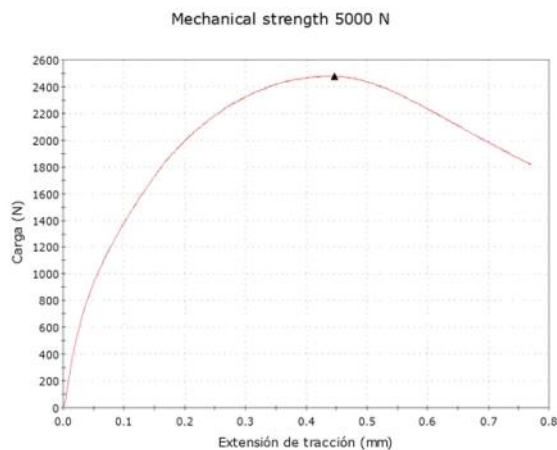
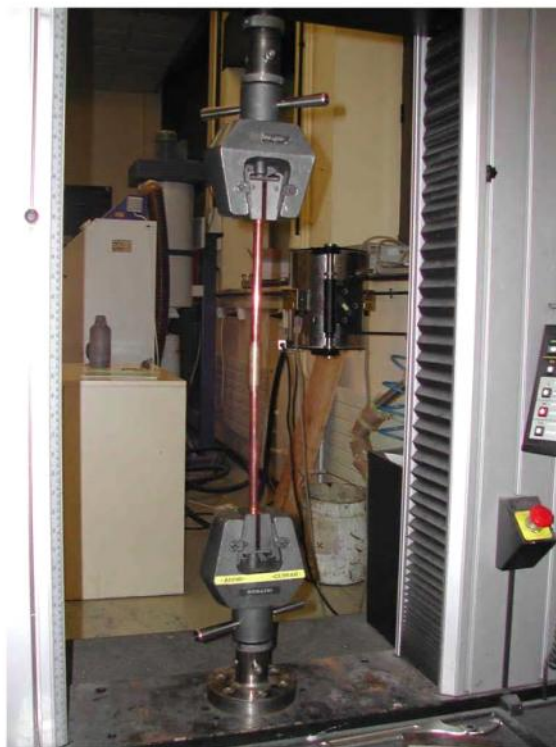
Figure 22

The sample was stressed on a suitable tensile test machine. At a tensile stress below 2500 N, the connection began to loosen and the test had to finish. The graphic and the assembly are shown as follows.

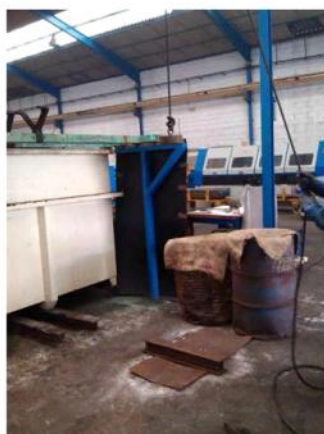
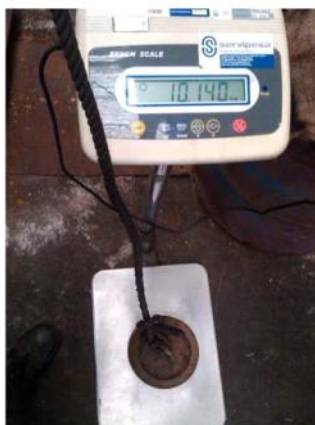
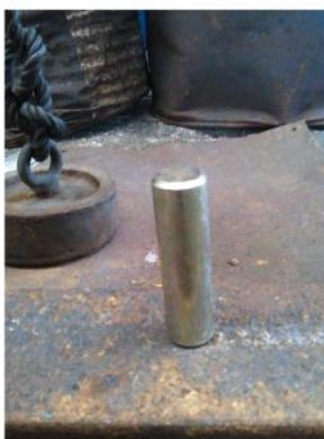
Figure 24

Three samples suffered a impact of 10 kg falling from a height of 1.5 m.

Acceptance criteria: No damage of beating head after test

RESULT: COMPLIES
